UNITED STATES ENVIRONMENTAL PROTECTION AGENCY

SUBJECT: Inspection Report Transmittal to Ledgeview Farms, LLC

On April 9, 2015, EPA conducted an inspection of your facility, Ledgeview Farms in De Pere, Wisconsin. The purpose of the inspection was to evaluate compliance with the Clean Water Act (CWA) and Administrative Order V-W-13-AO-22. Ledgeview Farms is a large Concentrated Animal Feeding Operation (CAFO) as defined in 40 C.F.R. § 122. During the inspection, we observed violations of the CWA and Administrative Order. The CWA and Order requires you to immediately cease all unauthorized discharges.

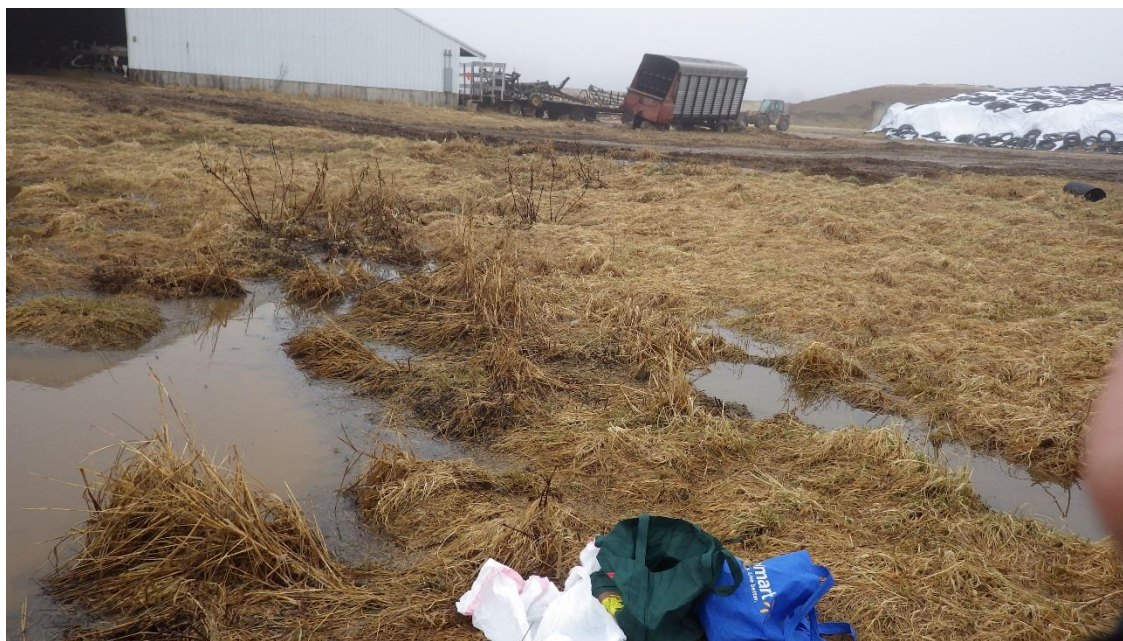
172: RIMG0181

Description: Sample S03 was taken at 11:32 a.m. from process wastewater in the grassed area.

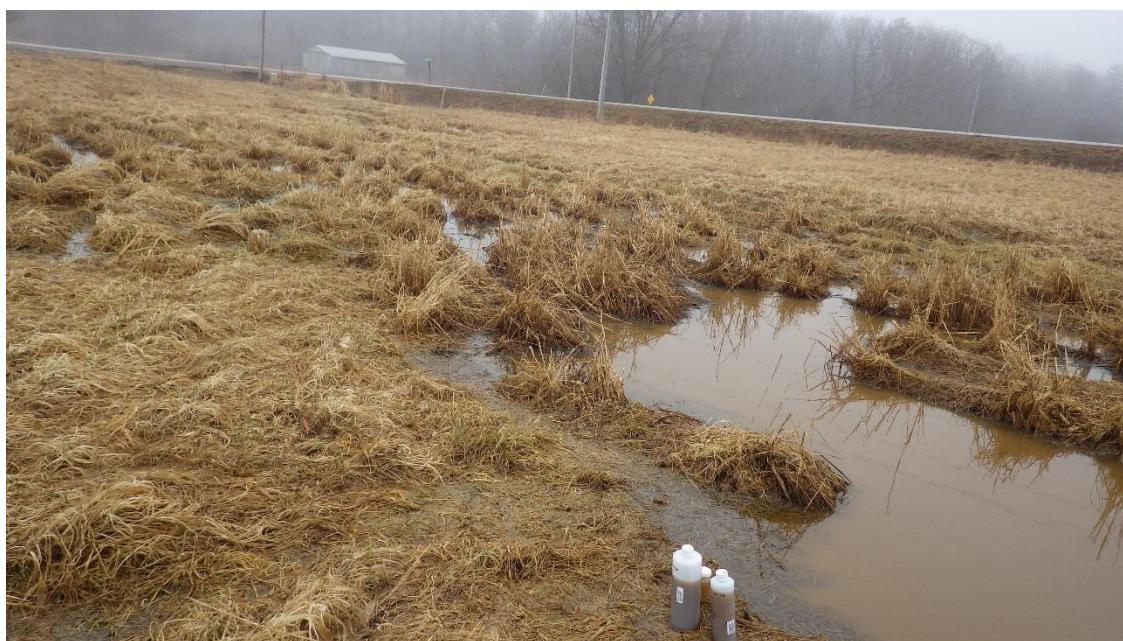
173: RIMG0182

Description: Sample S03 was taken at 11:32 a.m. from process wastewater in the grassed area.

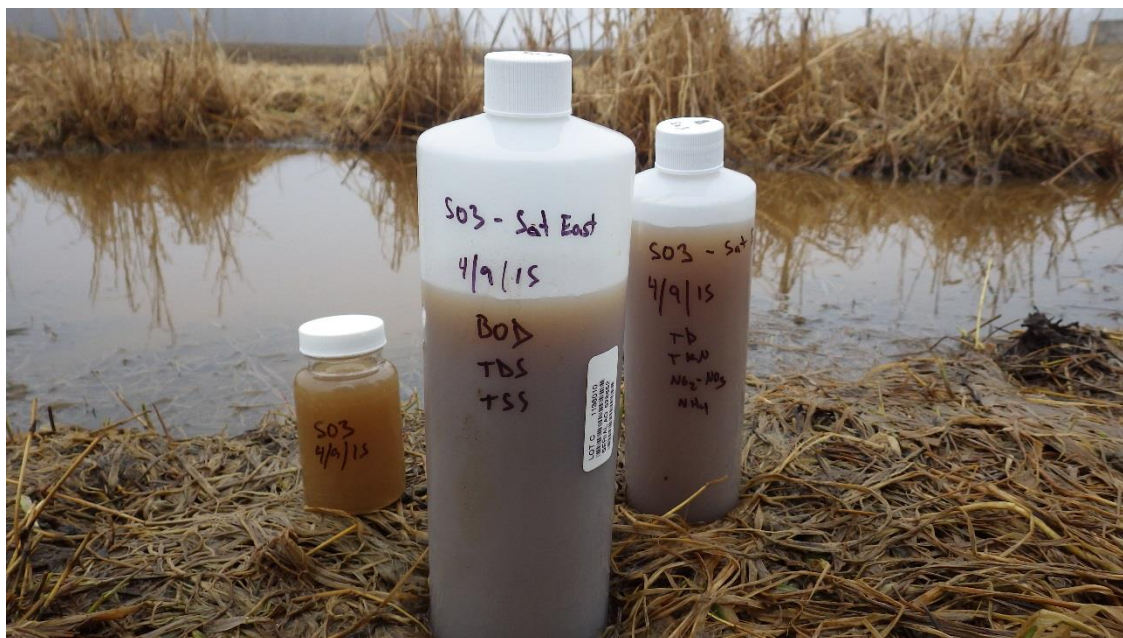
174: RIMG0183

Description: Sample S03 was taken at 11:32 a.m. from process wastewater in the grassed area.

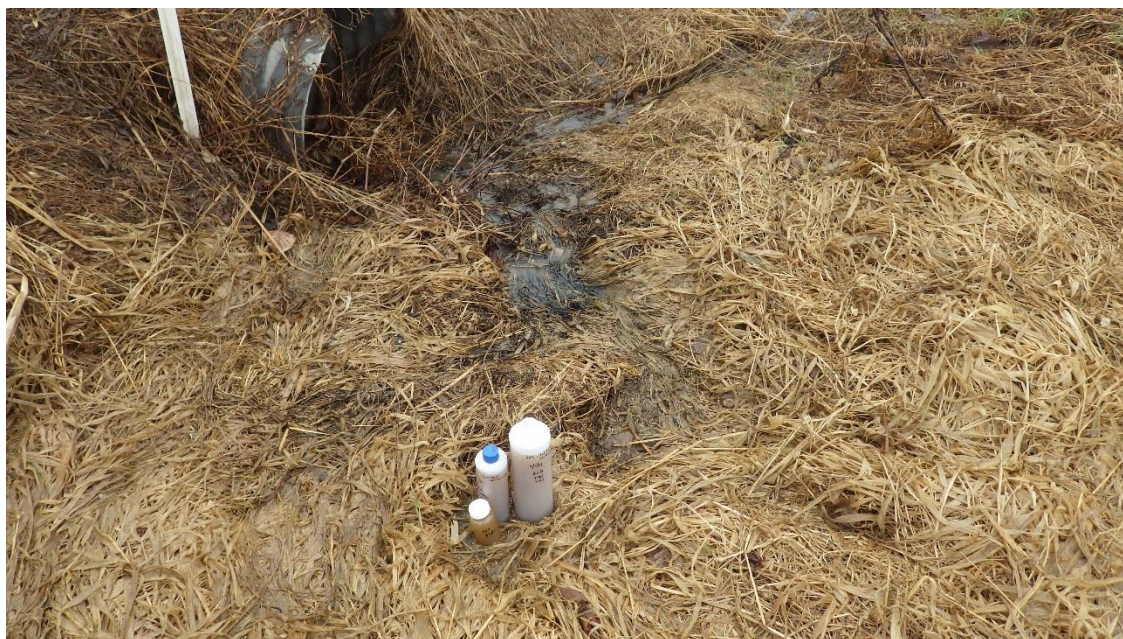
175: RIMG0184

Description: Sample S03 was taken at 11:32 a.m. from process wastewater in the grassed area.

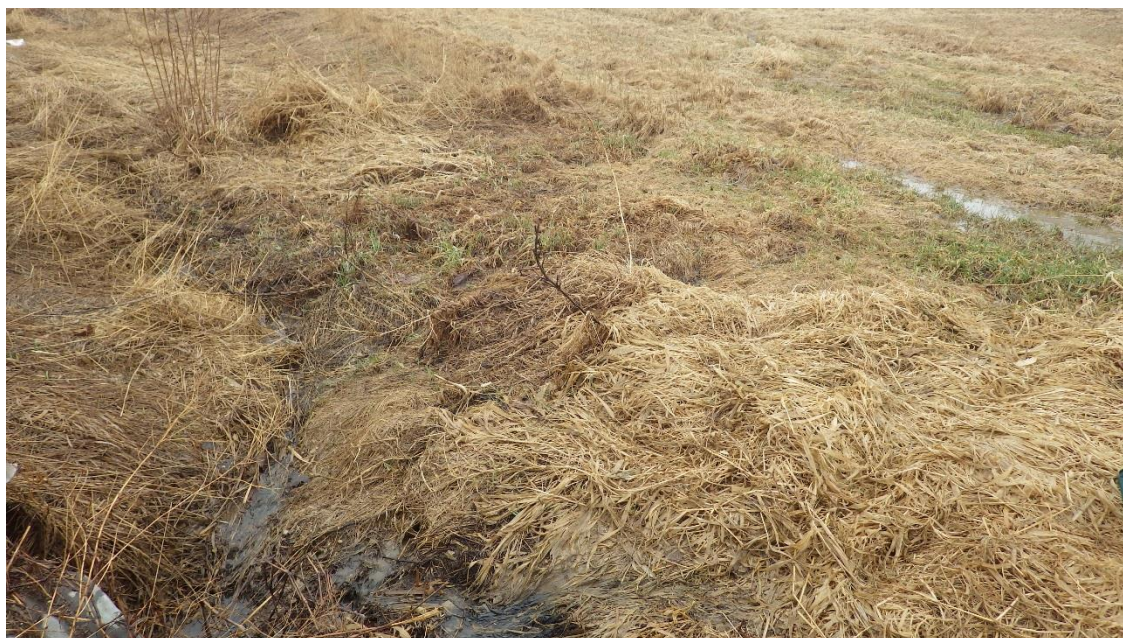
176: RIMG0185

Description: Sample S04 was taken at 11:35 a.m. from process wastewater before entering a culvert under County Road V.

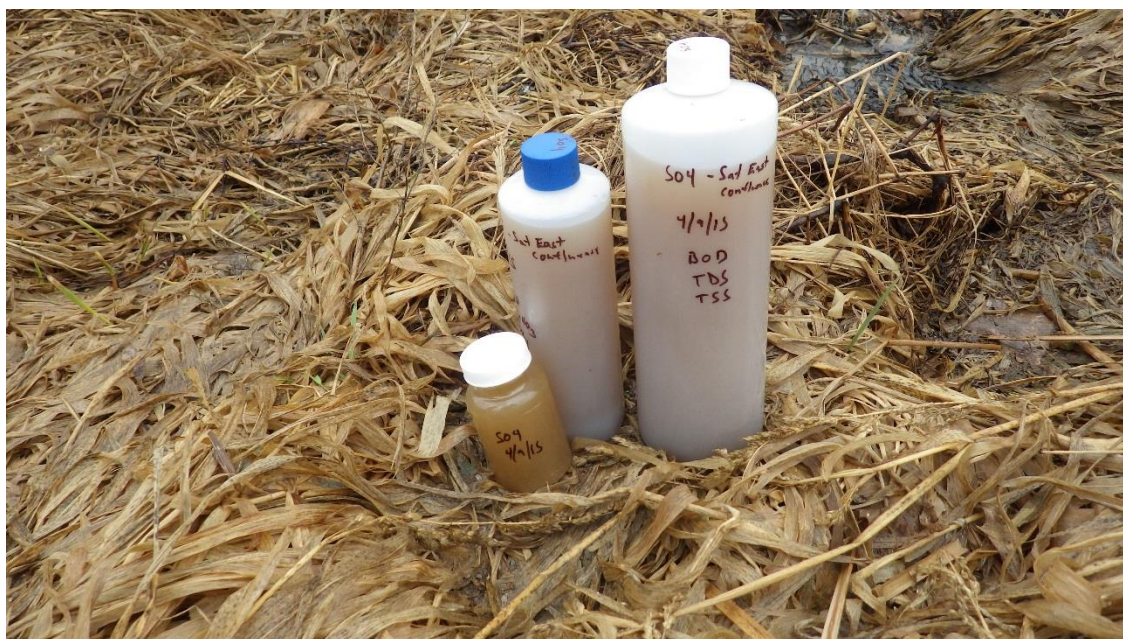
177: RIMG0186

Description: Sample S04 was taken at 11:35 a.m. from process wastewater before entering the culvert under County Road V.

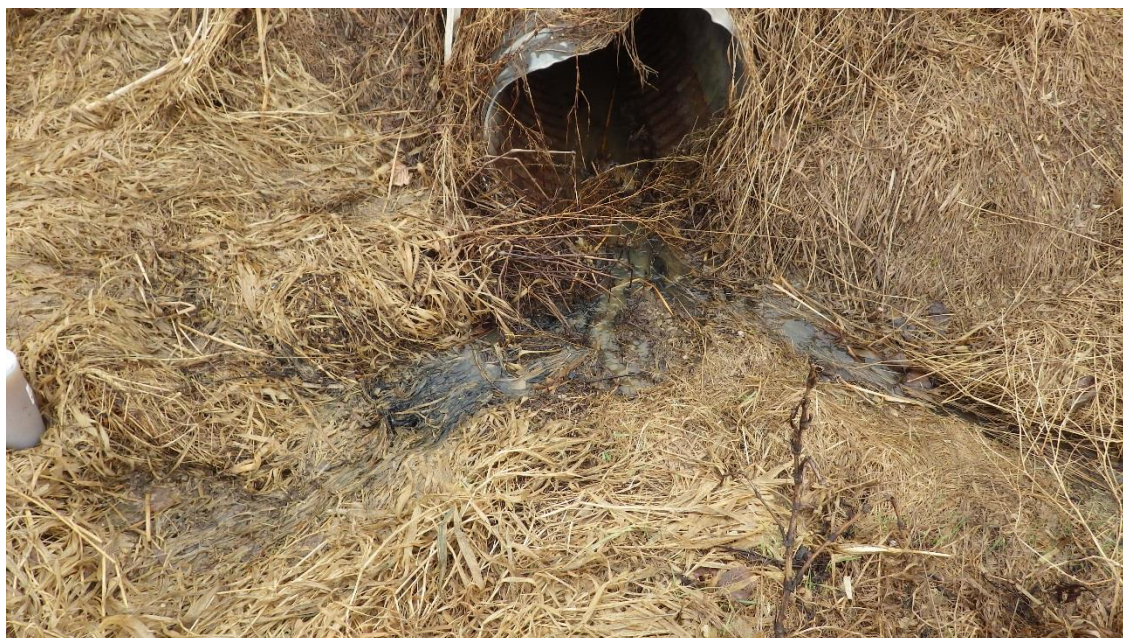
178: RIMG0187

Description: Sample S04 was taken at 11:35 a.m. from process wastewater before entering the culvert under County Road V.

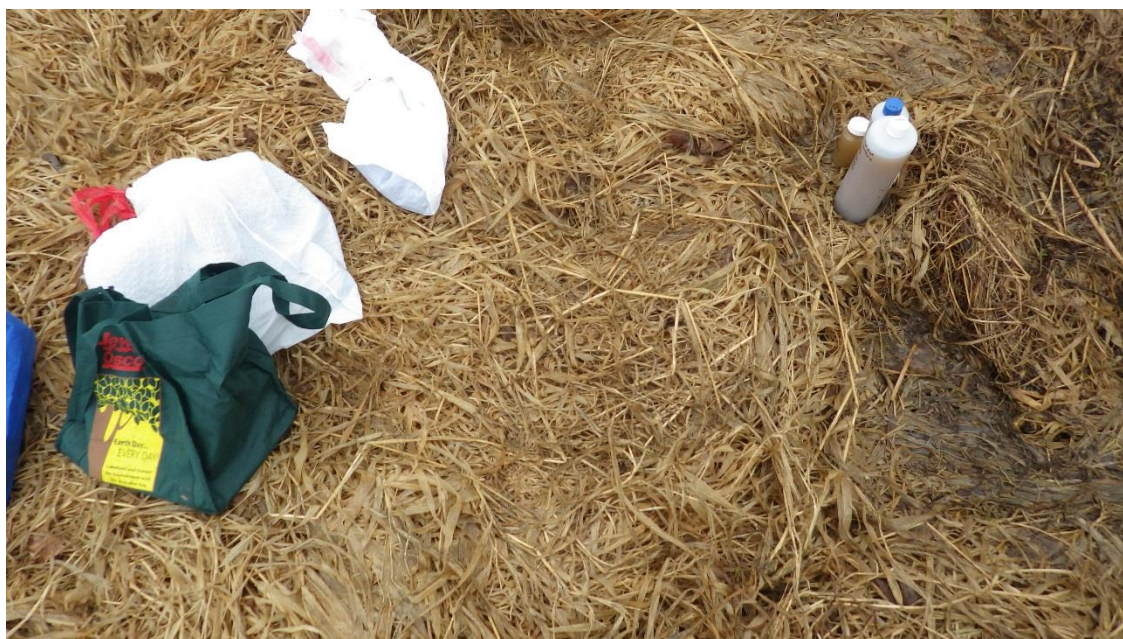
179: RIMG0188

Description: Sample S04 was taken at 11:35 a.m. from process wastewater before entering the culvert under County Road V.

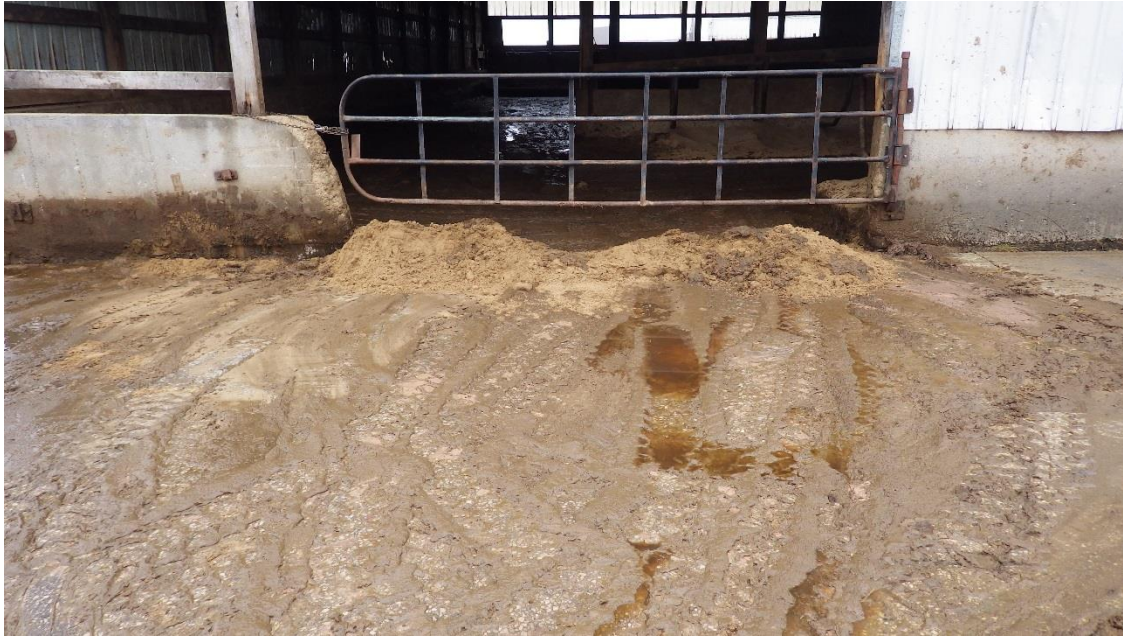
181: RIMG0190

Description: The sand berm in the northwest corner of the Milk Cow Barn had degraded since the start of the walkthrough. Manure and process wastewater were observed on the concrete.

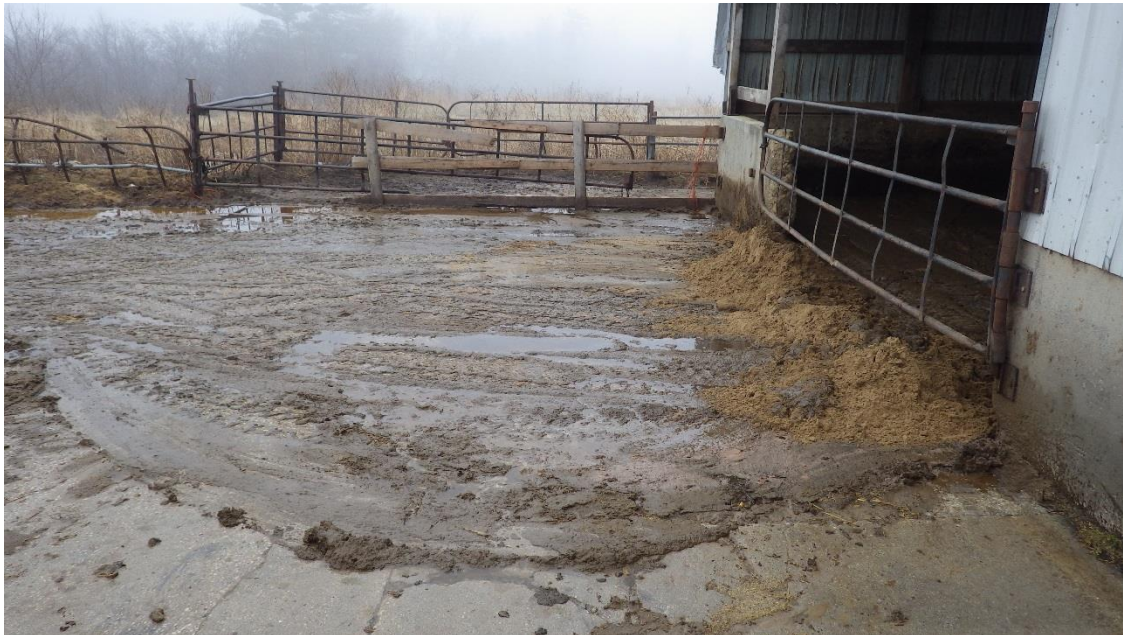
182: RIMG0191

Description: The sand berm in the northwest corner of the Milk Cow Barn had degraded since the start of the walkthrough. Manure and process wastewater were observed on the concrete.

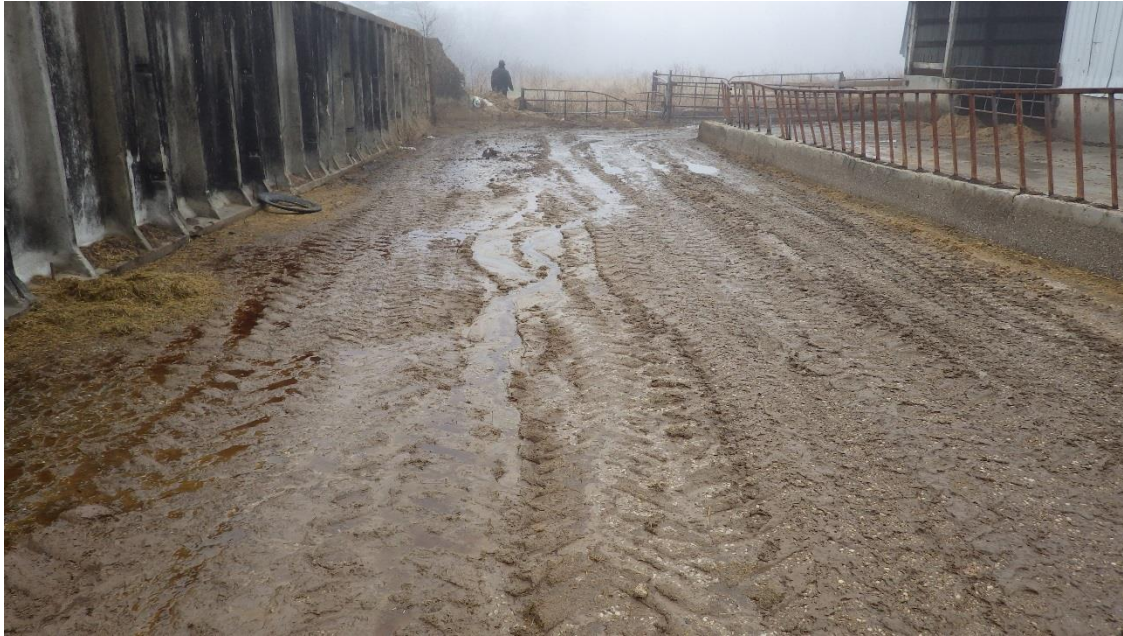
183: RIMG0192

Description: The access way between the feed bunker and the Milk Cow Barn contained the tracking of manure and process wastewater. Additionally, feed and leachate from the feed bunker were observed on the access way. Process wastewater drained north to the field north of the Milk Cow Barn.

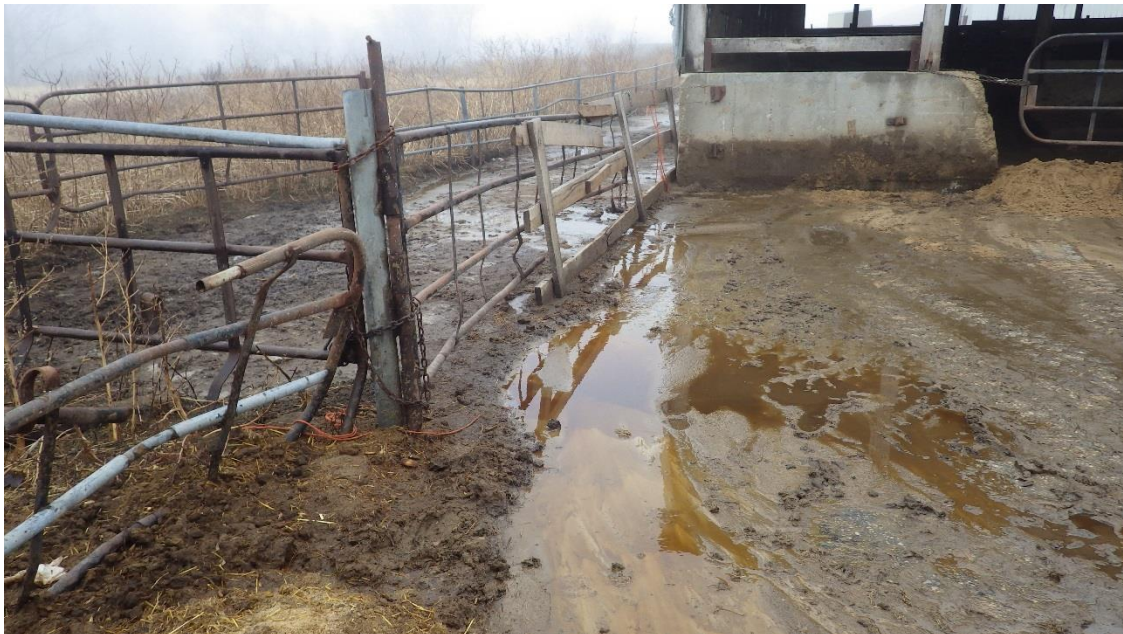
184: RIMG0193

Description: Process wastewater drained north to the field north of the Milk Cow Barn.

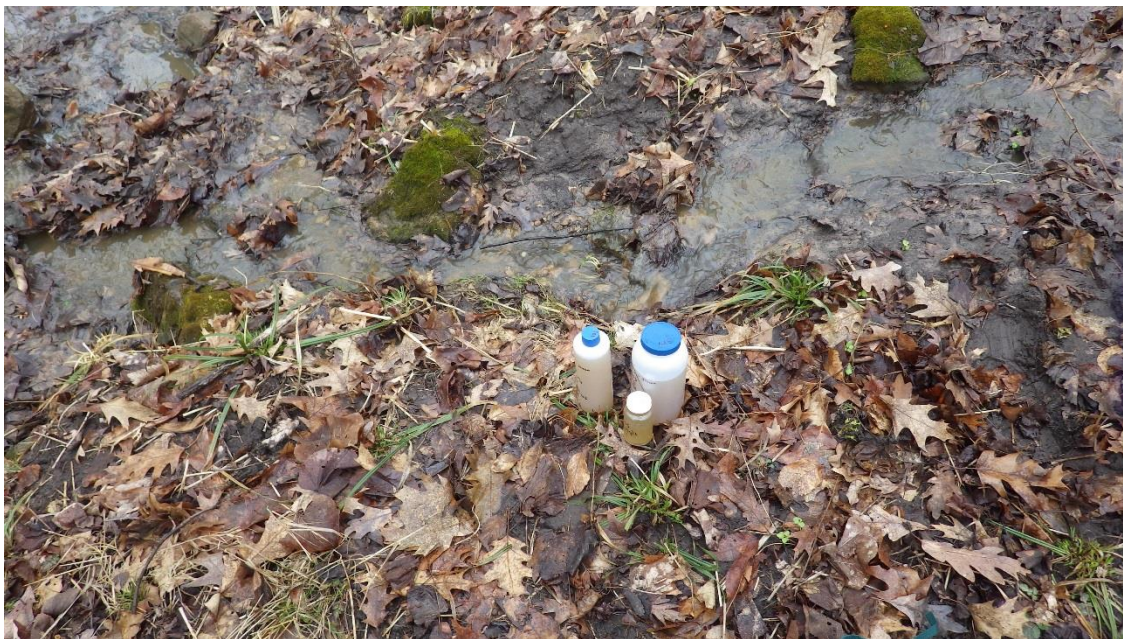
185: RIMG0194

Description: Sample S05 was taken at 12:45 p.m. from the process wastewater in the drainage pathway at the unnamed tributary on the east side of the Home site.

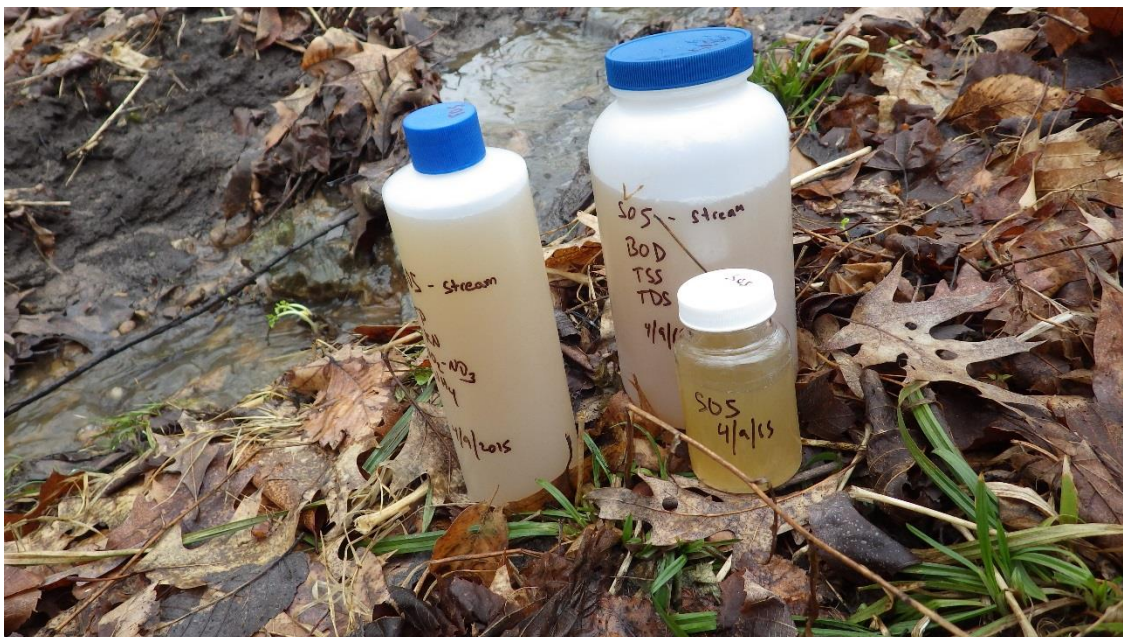
186: RIMG0195

Description: Sample S05 was taken at 12:45 p.m. from the process wastewater in the drainage pathway at the unnamed tributary on the east side of the Home site.

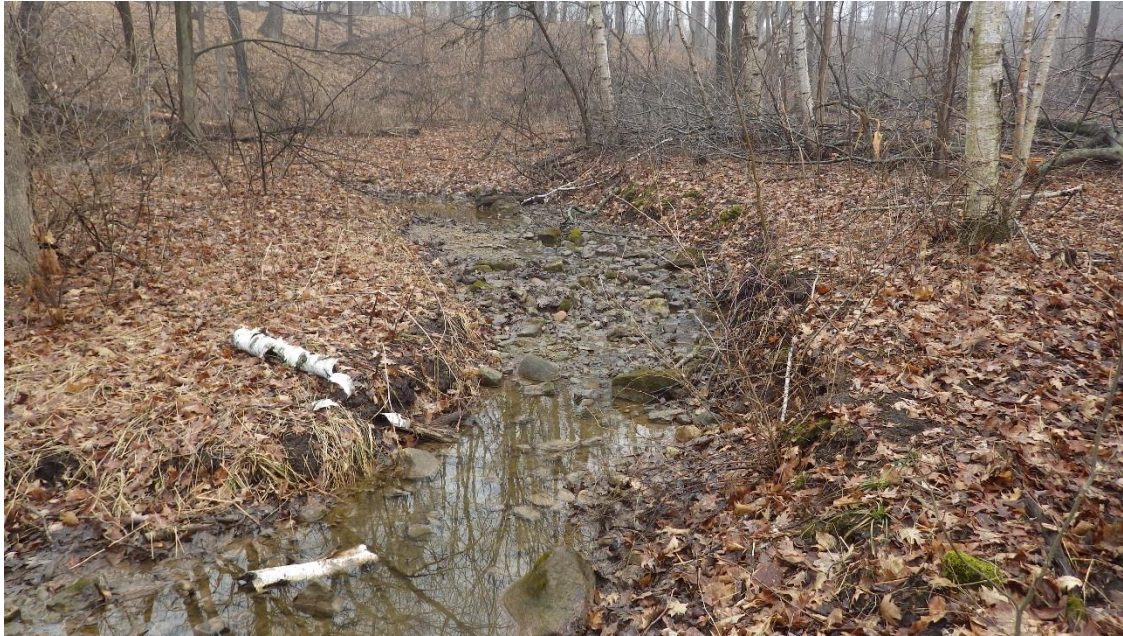
187: RIMG0196

Description: The unnamed tributary on the east side of the Home site contained a bed and bank.

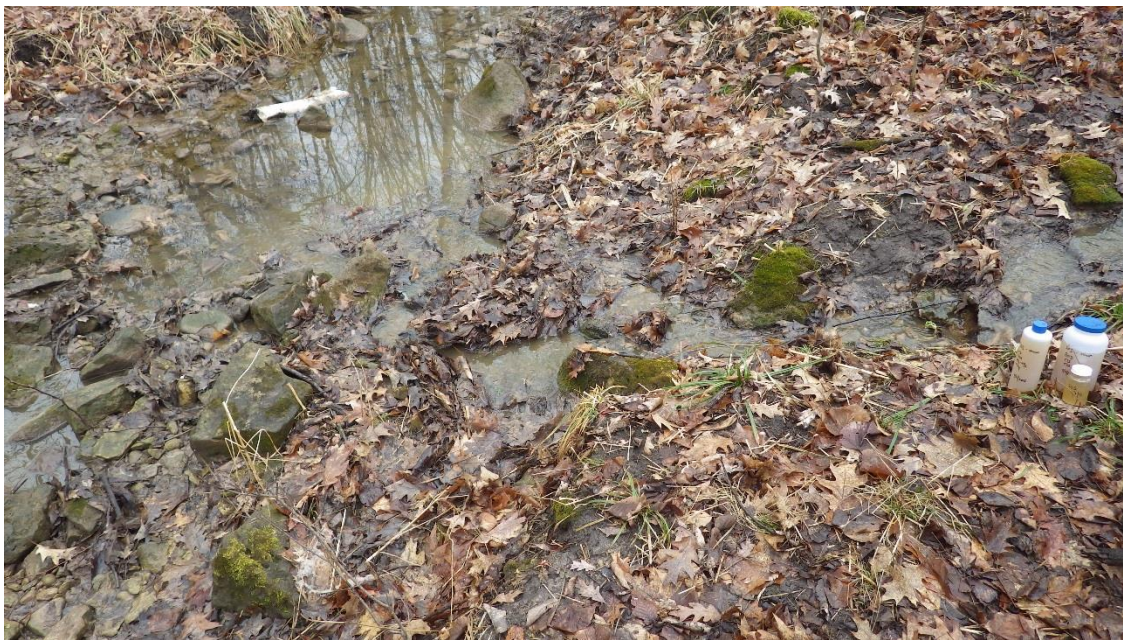
188: RIMG0197

Description: Sample S05 was taken at 12:45 p.m. from the process wastewater in the drainage pathway at the unnamed tributary on the east side of the Home site.

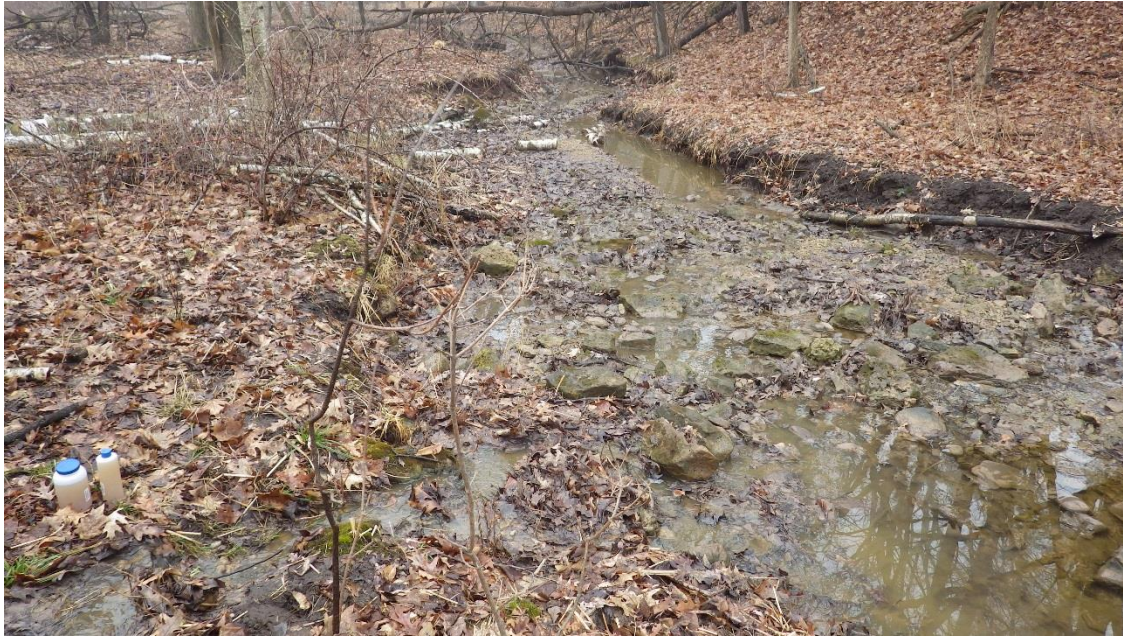
189: RIMG0198

Description: The unnamed tributary on the east side of the Home site contained a bed and bank.

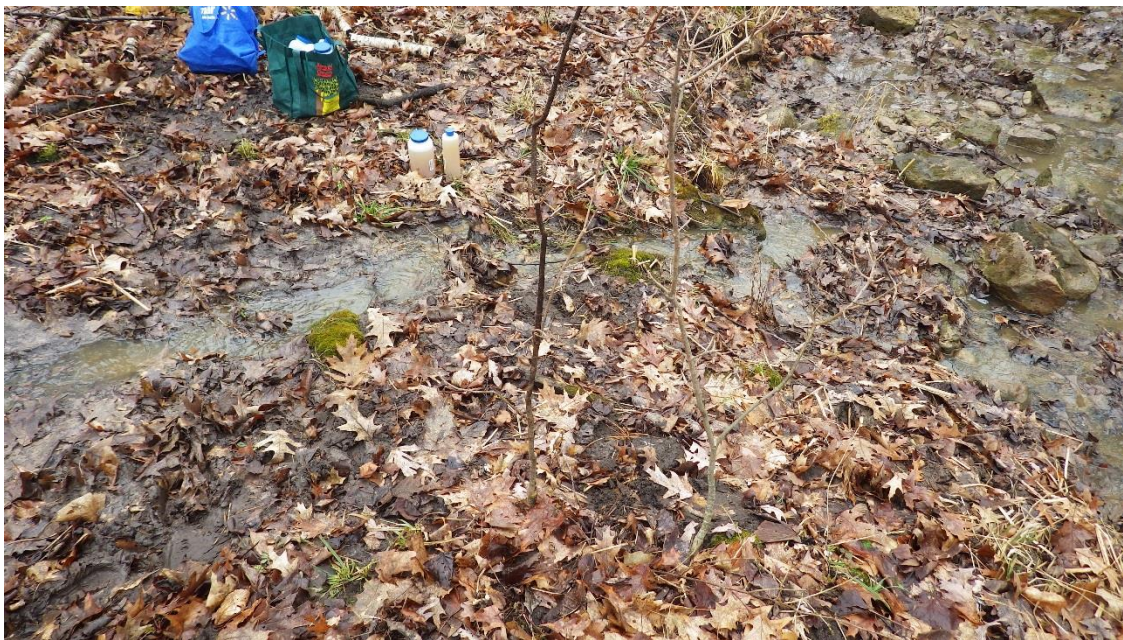
190: RIMG0199

Description: Sample S05 was taken at 12:45 p.m. from the process wastewater in the drainage pathway at the unnamed tributary on the east side of the Home site.

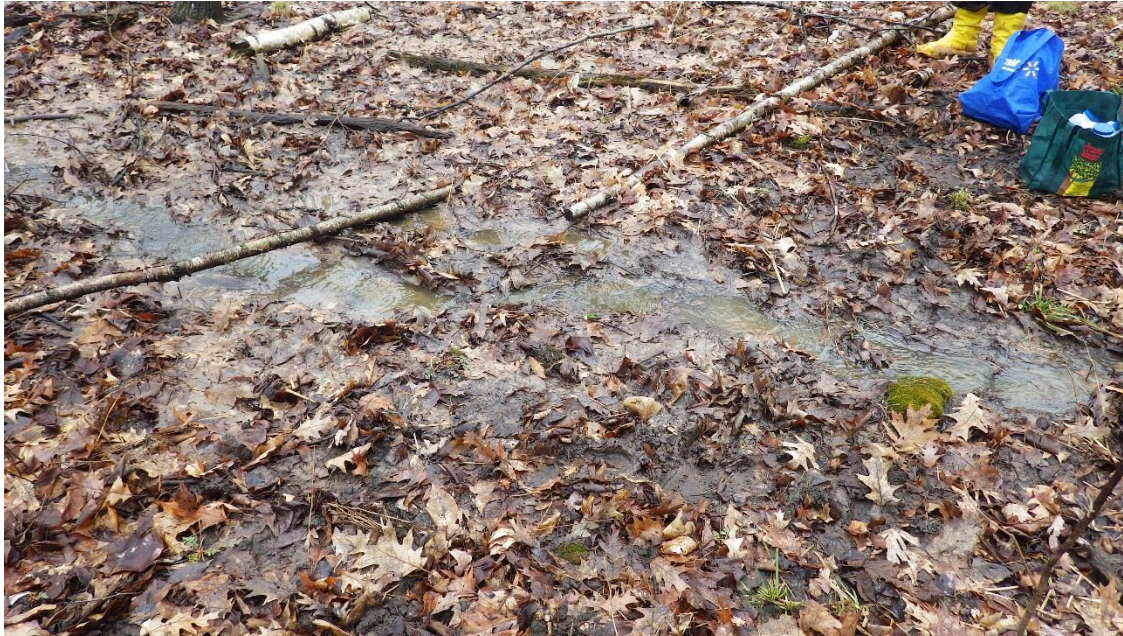
191: RIMG0200

Description: Sample S05 was taken at 12:45 p.m. from the process wastewater in the drainage pathway at the unnamed tributary on the east side of the Home site.

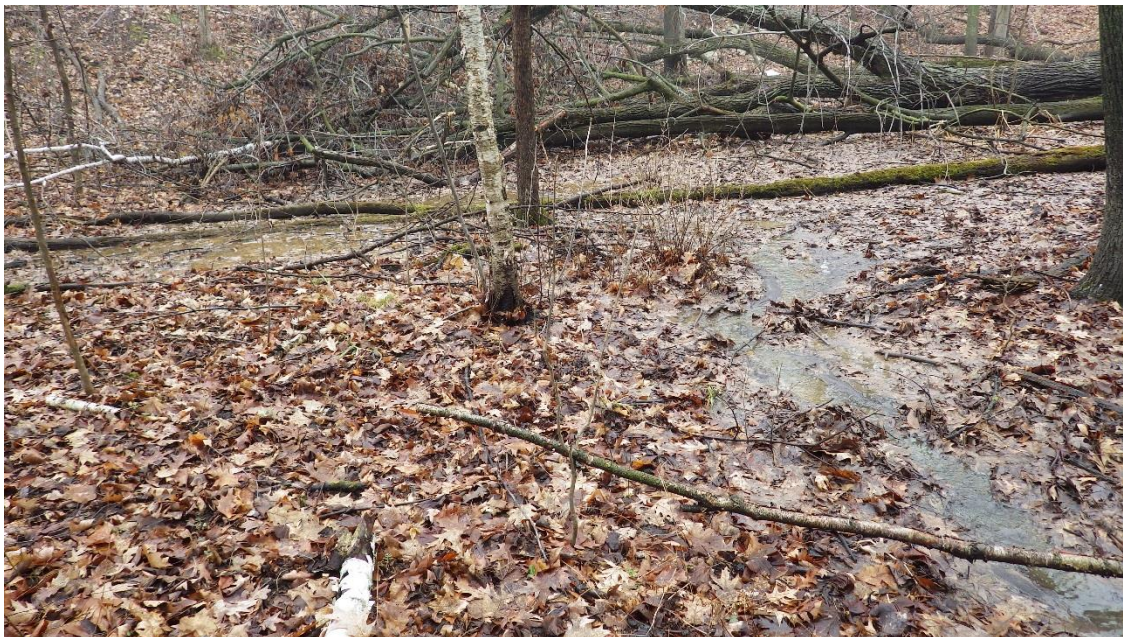
192: RIMG0201

Description: The drainage pathway flowed to the unnamed tributary.

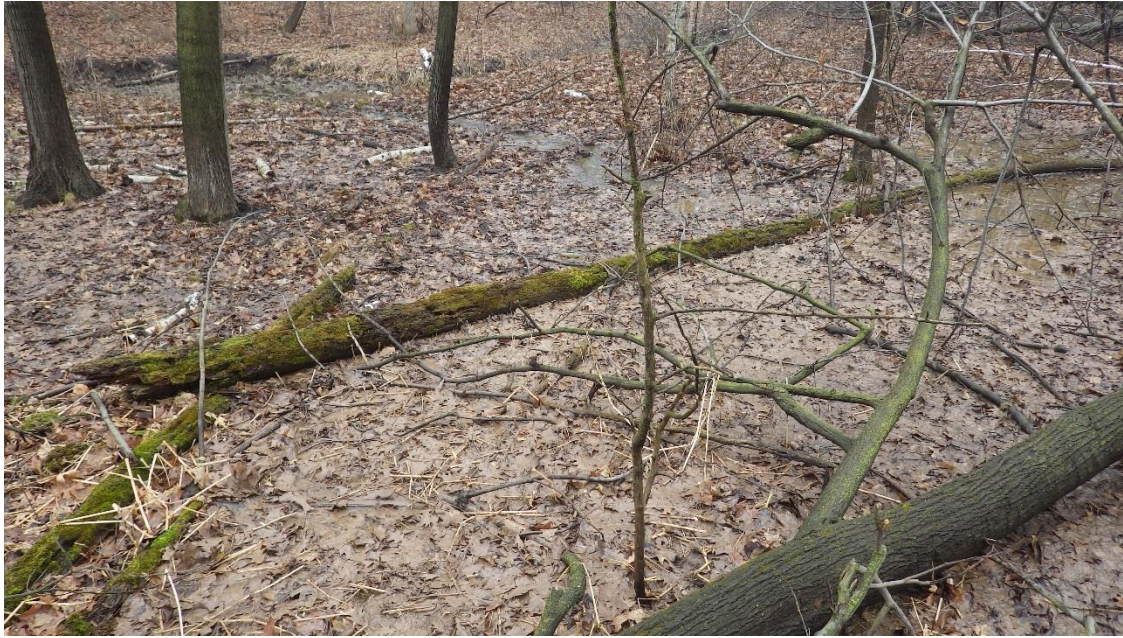
193: RIMG0202

Description: Red/orange sediment covered the forest floor. The sediment had been deposited from the borrow area.

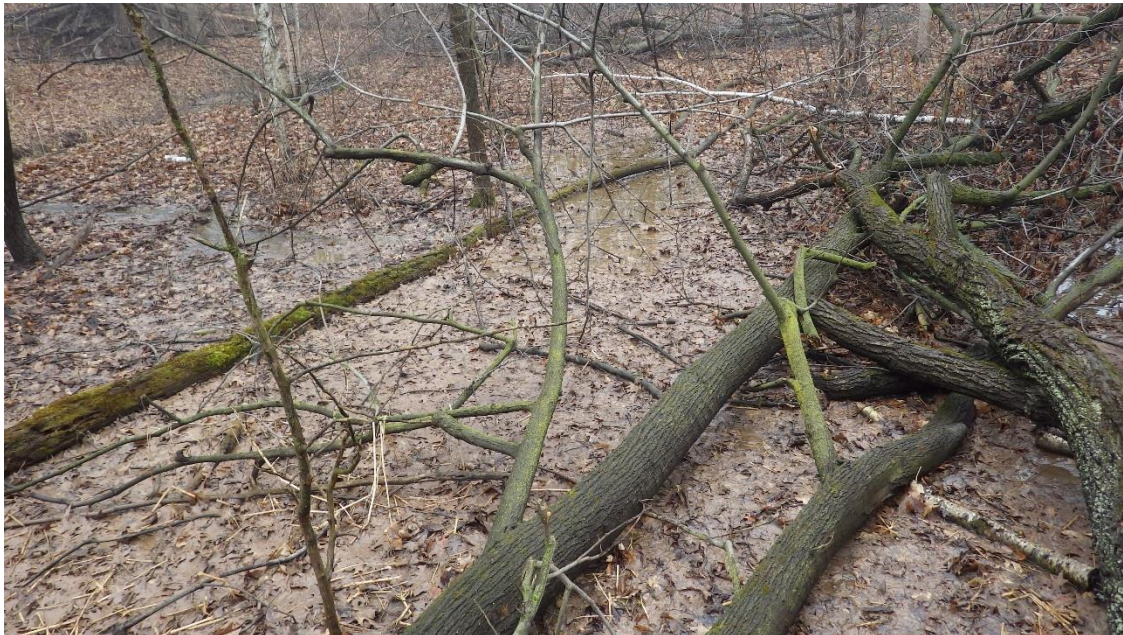
194: RIMG0203

Description: Red/orange sediment covered the forest floor. The sediment had been deposited from the borrow area.

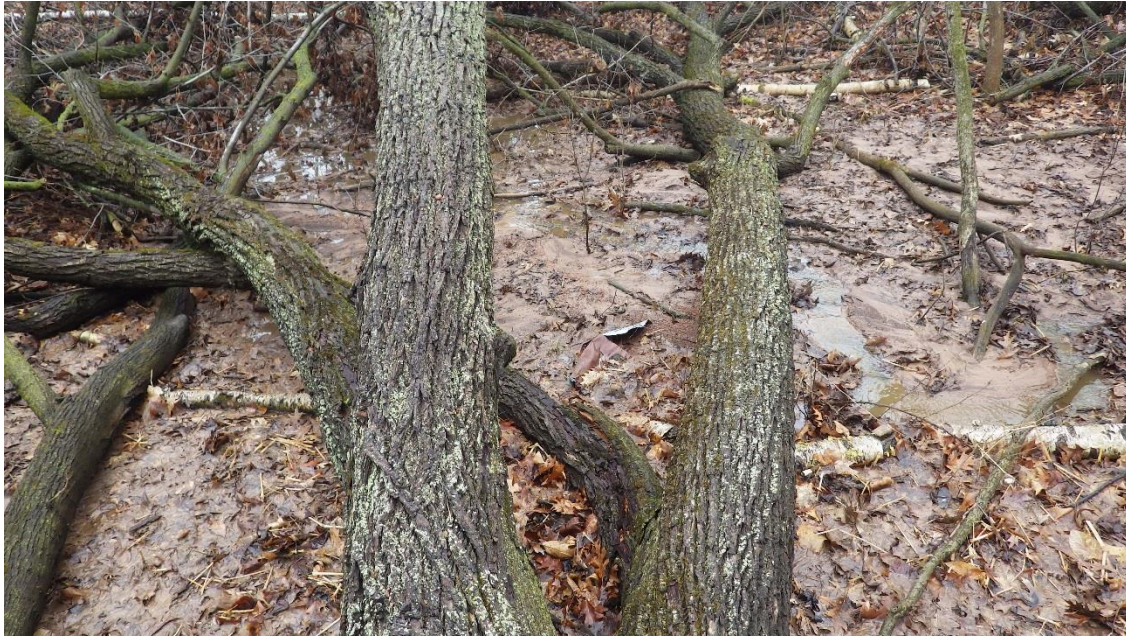
195: RIMG0204

Description: Red/orange sediment covered the forest floor. The sediment had been deposited from the borrow area.

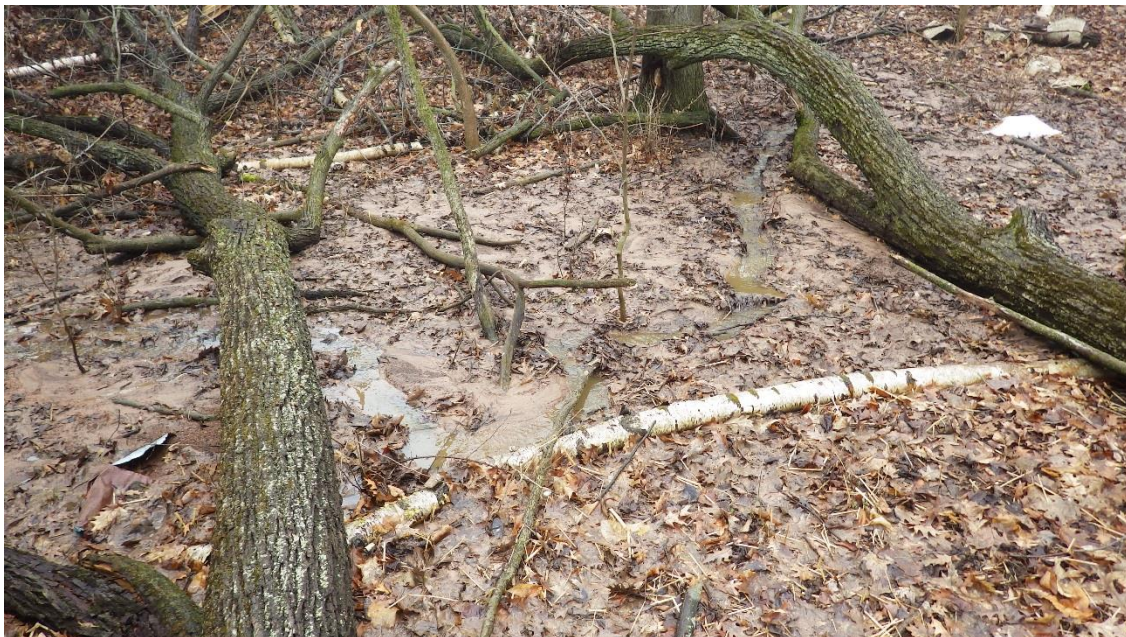
196: RIMG0205

Description: Red/orange sediment covered the forest floor. The sediment had been deposited from the borrow area.

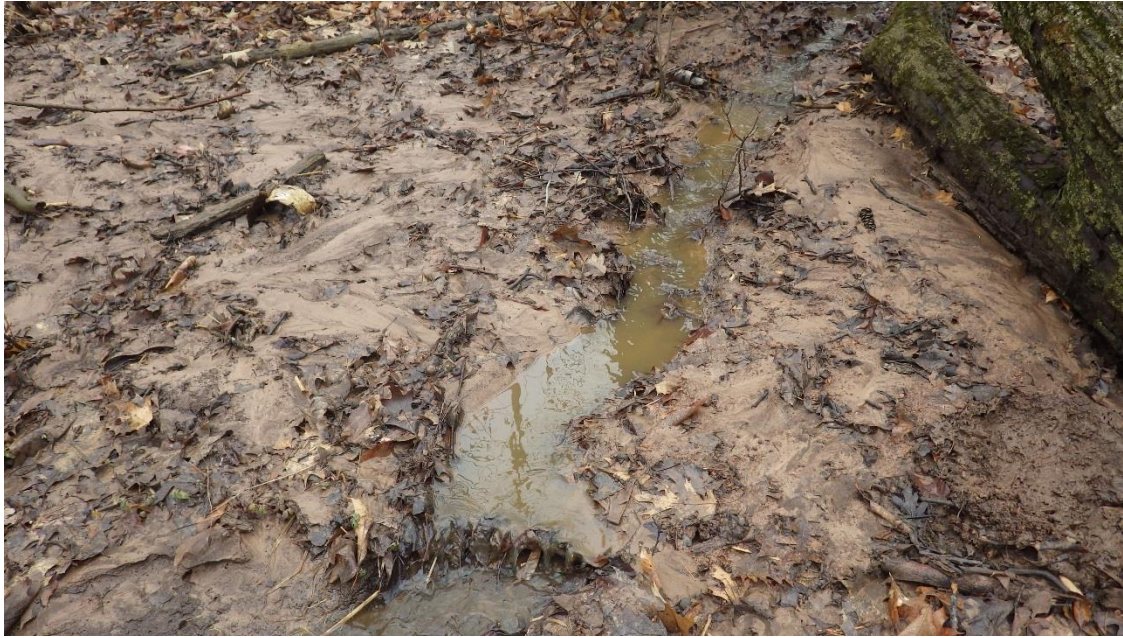
197: RIMG0206

Description: Red/orange sediment covered the forest floor. The sediment had been deposited from the borrow area. The drainage pathway flowed to the unnamed tributary.

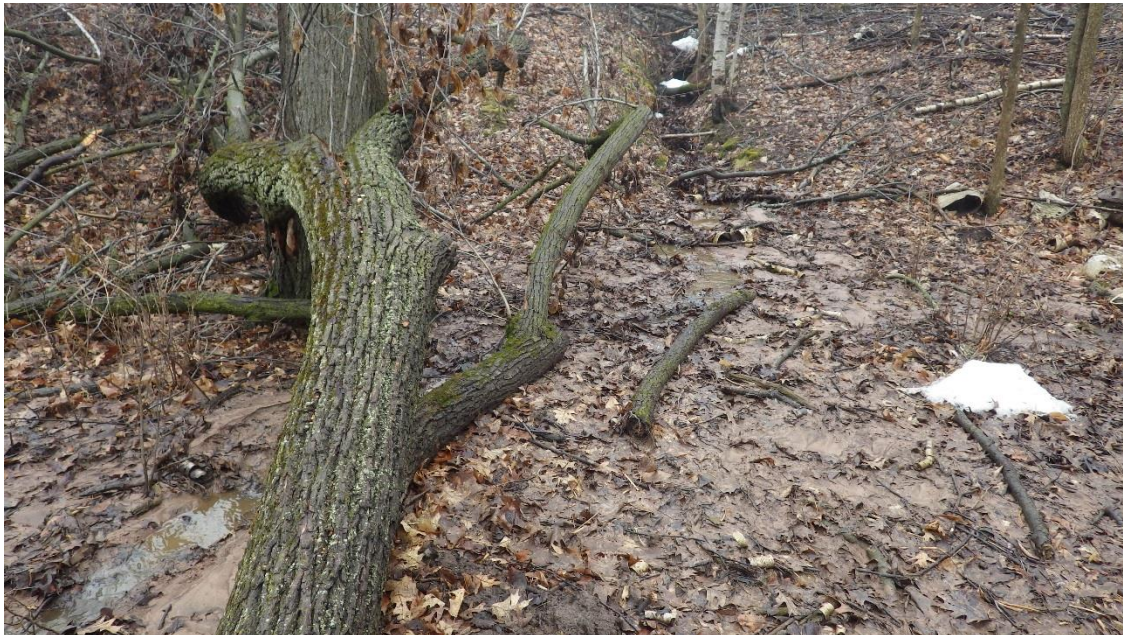
198: RIMG0207

Description: Red/orange sediment covered the forest floor. The sediment had been deposited from the borrow area. The drainage pathway flowed to the unnamed tributary.

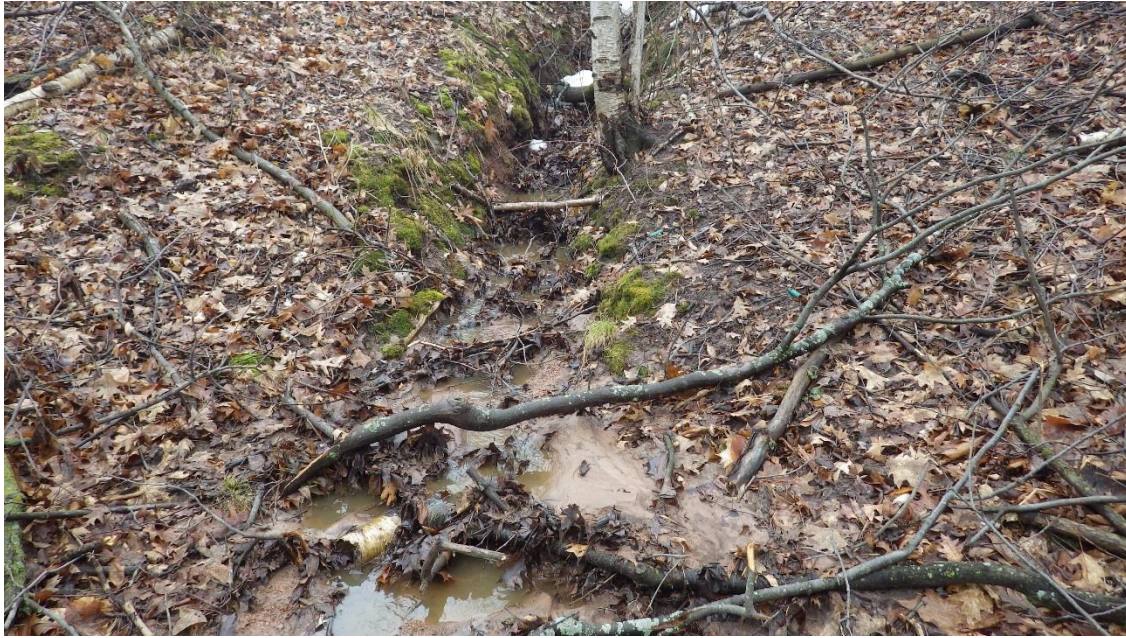
199: RIMG0208

Description: The drainage pathway flowed to the unnamed tributary.

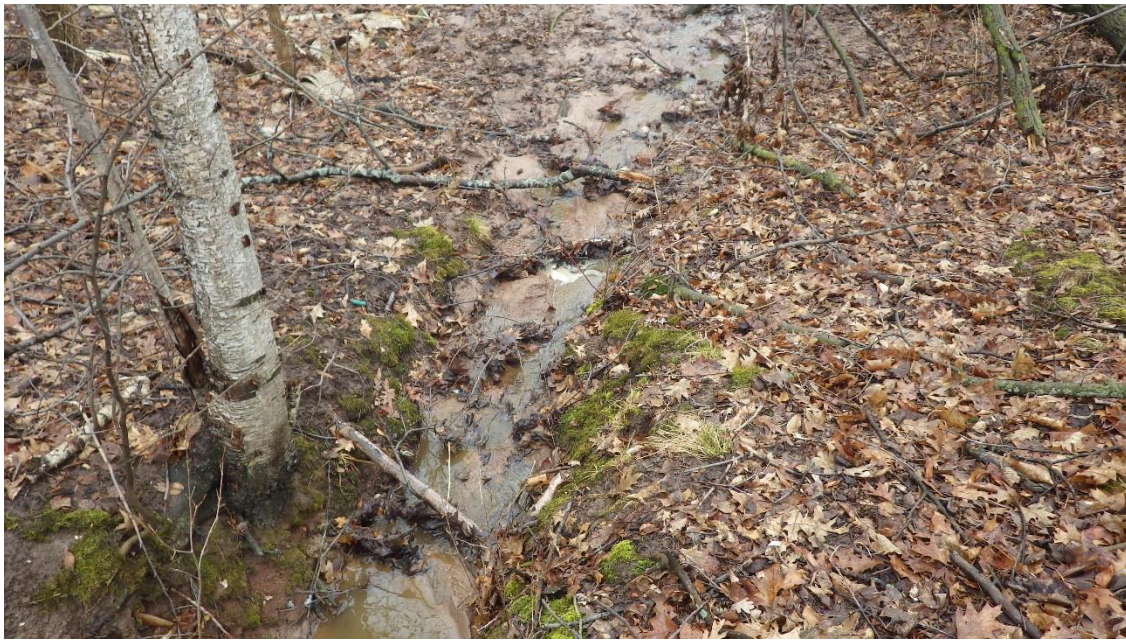
200: RIMG0209

Description: The drainage pathway flowed to the unnamed tributary.

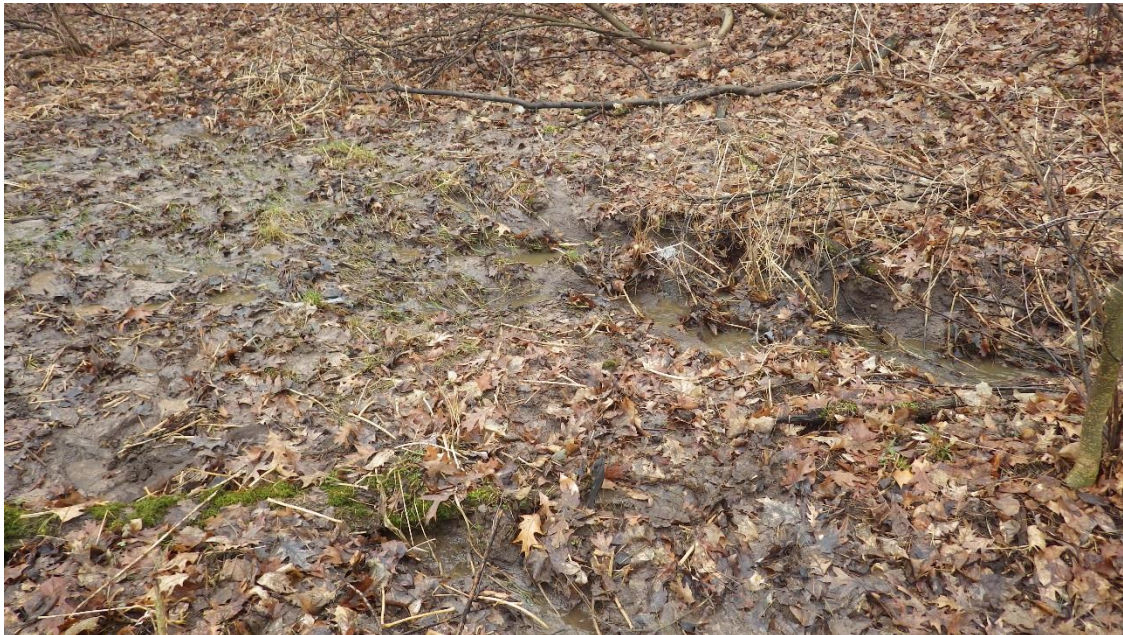
206: RIMG0215

Description: The drainage pathway flowed to the unnamed tributary.

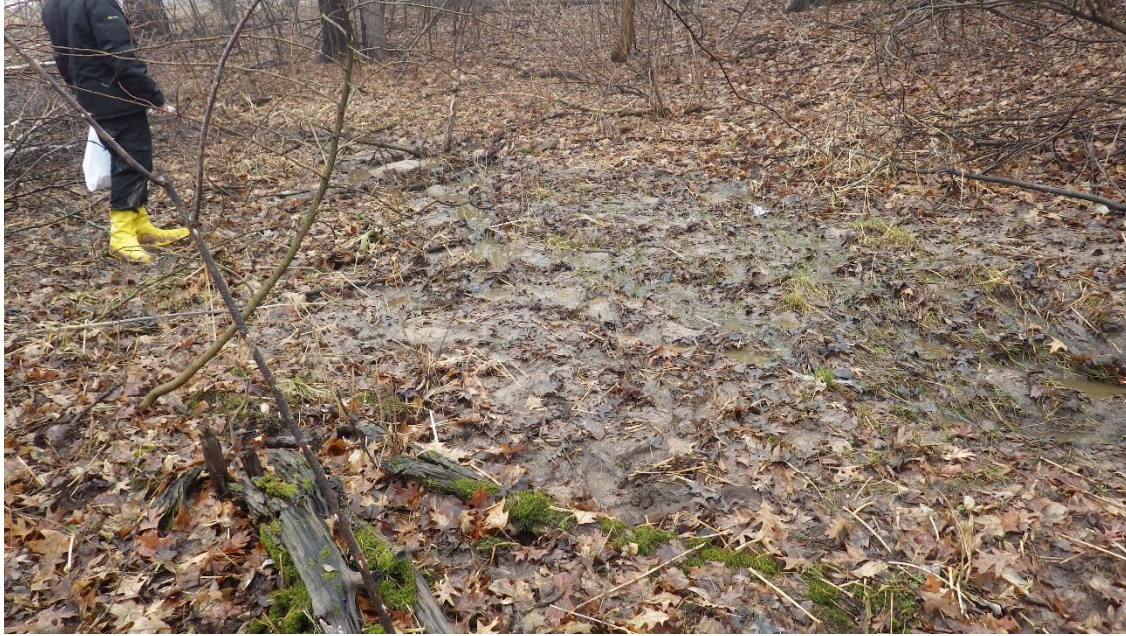
207: RIMG0216

Description: The drainage pathway flowed to the unnamed tributary.
